**Flood Control Project Maintenance
Levee Inspections**

Maintenance Issue Types Only, Levee Inspection Report By Mile - Spring 2019

Sacramento River West Side Levee District

Waterway	Bank	Unit Miles	Inspection Start/End	Inspector
Unit No. 01 Sacramento River	Right	49.64	04/02/2019 04/03/2019	Zach Jojola

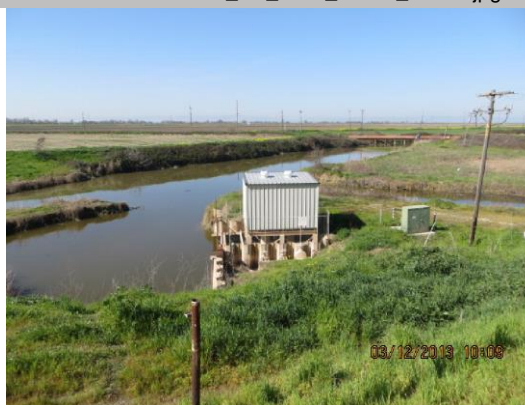
Photo 1 of 3 : UCIP_SP_2019_10087_17235.jpg

LM Start	0.14	Rating **	M	Issue No.	1551	
LM End	0.14	Issue Type +	Ma	Location *		
Category	Supplemental			GPS Latitude/Longitude		
				Start		End
Item	DWR UCIP LMA Responsibility			38.801471 °		38.801471 °
				-121.725171 °		-121.725171 °
DWR ID	20224					
Comment Code						
Inspector Comment						
FS_ID:10087 DS_ID:20224 EP_NO: N/A Repair Type: Non-Urgent Crossing Status: Found UCIP Comments: Headwall on WS undermined about 3-4-feet. FIELD_STRUCT_DESC: 1 of 3: 36-inch steel drainage pipe through the levee, 30.0 feet below the crown. Flap gate on the waterside (WS) end. 24-inch pipe sleeved through the 36-inch pipe. Annular space between pipes grouted. Pumps in pump house with walkway on landside (LS) toe. [Additional Reference(s): DWR Levee Log, 2006. USACE Sacramento O&M Manual 130, May 1960 (HLM 0.15)]. FS Date: 3/12/2013

Pumphouse at LS toe.

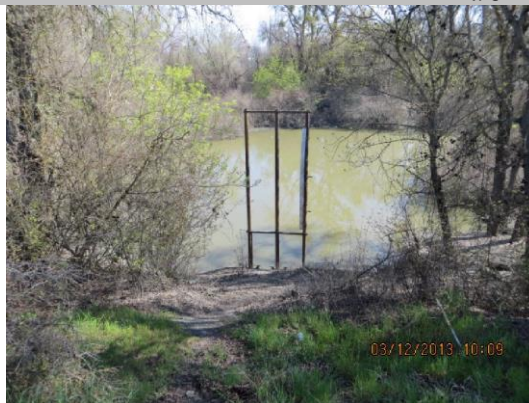
Photo 2 of 3 : UCIP_SP_2019_10087_17234.jpg

Air vents at outlet on WS toe.

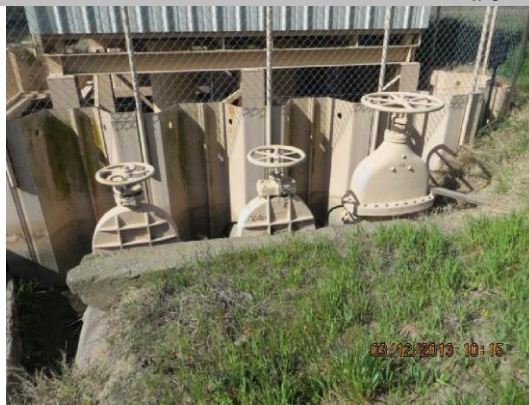
Photo 3 of 3 : UCIP_SP_2019_10087_17233.jpg

Slide gates at pumphouse on LS toe.

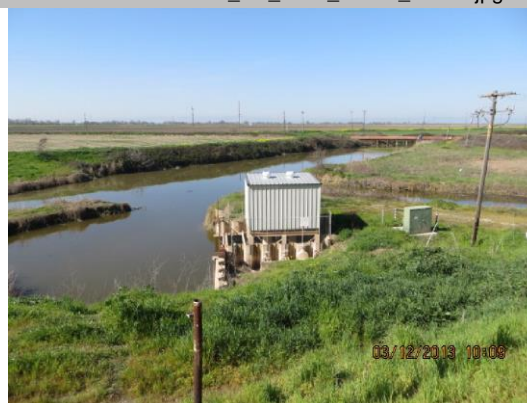
Photo 1 of 3 : UCIP_SP_2019_10085_17227.jpg

Comment Code						
Inspector Comment						
FS_ID:10085						
DS_ID:20356						
EP_NO: N/A						
Repair Type: Non-Urgent						
Crossing Status: Found						
UCIP Comments: Headwall undermined 3-4-feet on WS toe.						
FIELD_STRUCT_DESC: 2 of 3: 36-inch steel drainage pipe through the						
levee, 30 feet below the crown. Flap gate on the waterside (WS) end.						
24-inch pipe sleeved through the 36-inch pipe. Annular space between						
pipes grouted. Pumps inside pump house with a walkway on the						
landside (LS) toe. [Additional Reference(s): DWR Levee Log, 2006.						
USACE Sacramento O&M Manual 130, May 1960 (HLM 0.15)].						
FS Date: 3/12/2013

Pump house on LS toe.

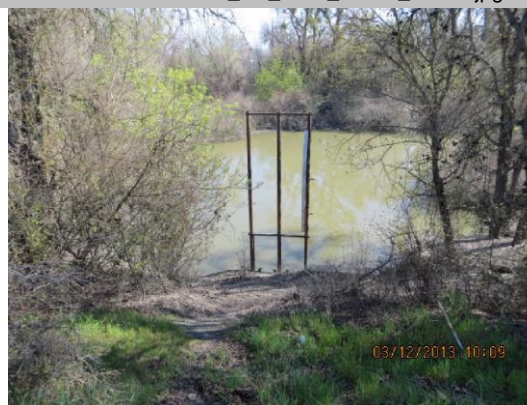
Photo 2 of 3 : UCIP_SP_2019_10085_17226.jpg

Air vents on pipes at WS toe.

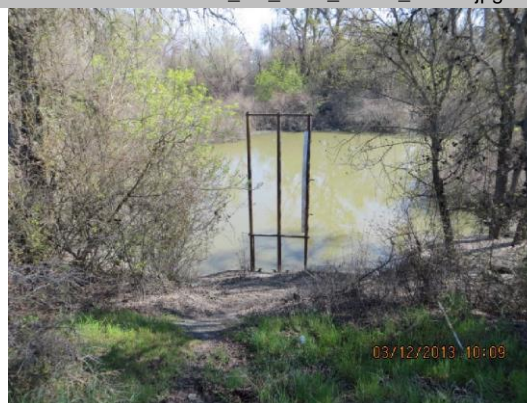
Photo 2 of 3 : UCIP_SP_2019_10910_18184.jpg

Air vents on pipes at WS toe.

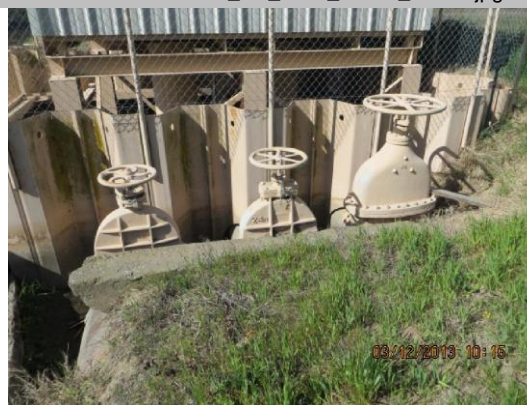
Photo 3 of 3 : UCIP_SP_2019_10910_18183.jpg

Slide gates at pumphouse on LS toe.

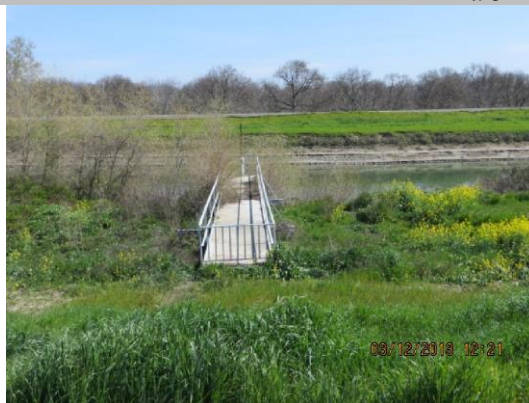
Photo 1 of 3 : UCIP_SP_2019_10125_17283.jpg

Steel walkway on WS berm with Slide gate actuator.

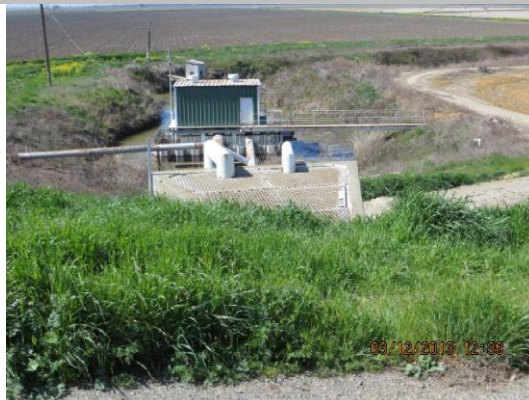
Photo 2 of 3 : UCIP_SP_2019_10125_17282.jpg

Pumphouse at LS toe and concrete riser on LS shoulder.

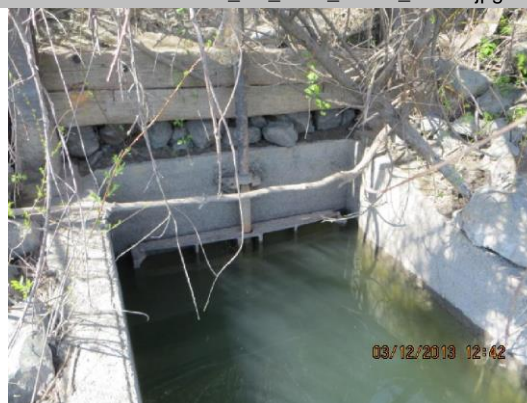
Photo 3 of 3 : UCIP_SP_2019_10125_17281.jpg

Slide gate at outlet at river side.

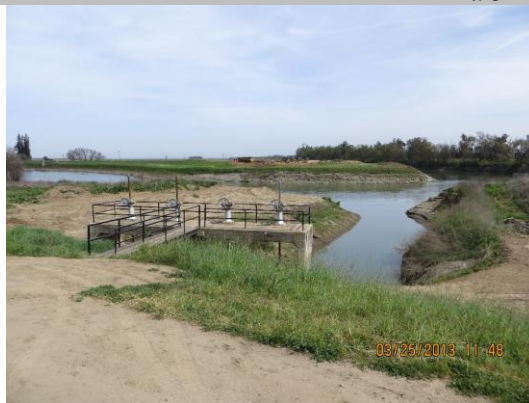
Photo 2 of 3 : UCIP_SP_2019_10146_17311.jpg

Walkway to slide gate actuators on WS shoulder.

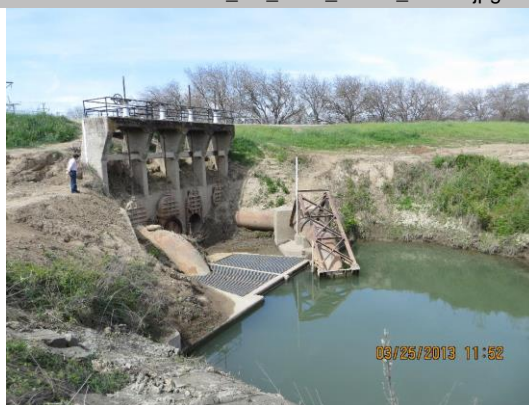
Photo 3 of 3 : UCIP_SP_2019_10146_17310.jpg

Pipes at outlet on WS toe.

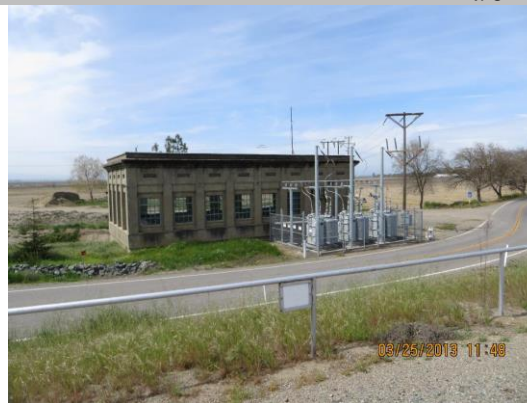
Photo 1 of 3 : UCIP_SP_2019_10147_17316.jpg

Pumphouse on LS toe.

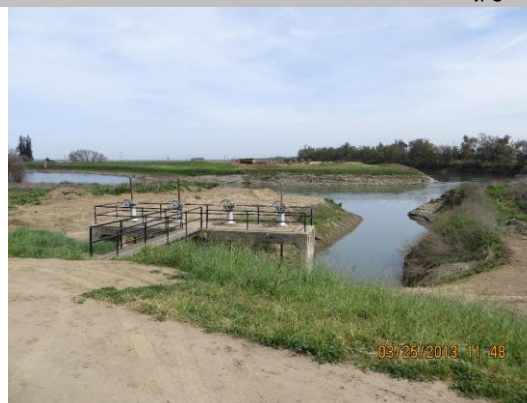
Photo 2 of 3 : UCIP_SP_2019_10147_17315.jpg

Walkway to slide gate actuators on WS shoulder.

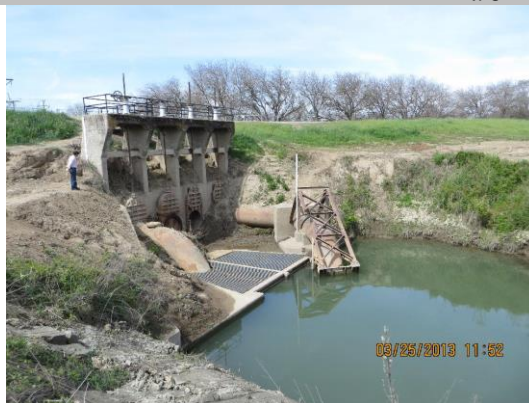
Photo 3 of 3 : UCIP_SP_2019_10147_17314.jpg

Slide gates and pipes at outlet structure on WS toe.

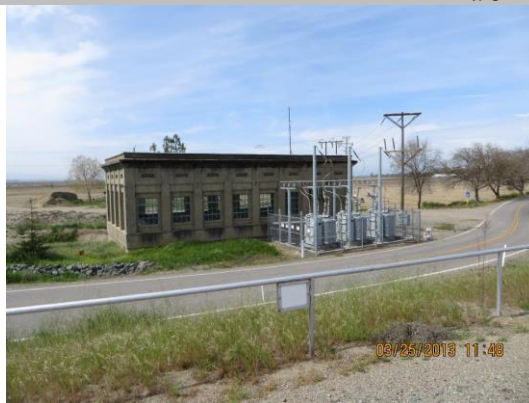
Photo 1 of 3 : UCIP_SP_2019_10149_17324.jpg

Pumphouse on LS.

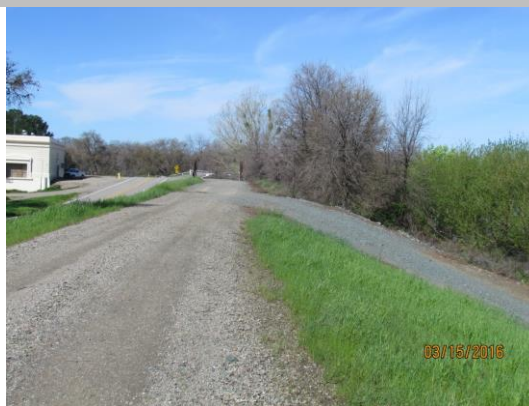
Photo 1 of 2 : SP_2019_NA0016_435_29_20190304_00007.jpg

LM Start	9.68	Rating **	A/W	Issue No.	29
LM End	9.79	Issue Type +	Ma	Location *	WS
Category	Earthen Levee			GPS Latitude/Longitude	
				Start	End
Item	Vegetation			38.862345 °	38.862848 °
				-121.791337 °	-121.793267 °
DWR ID	DWR_NA0016_01_s_2012_29				
Comment Code					
V8 : Environmental Requirements.					
Inspector Comment

View of the revegetation site on the waterward side of the levee looking upstream. Spring 2016.

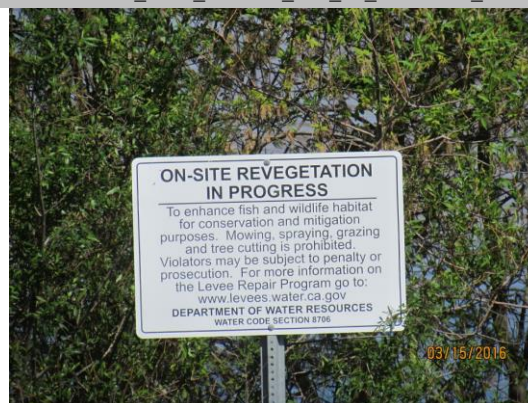
Photo 2 of 2 : SP_2019_NA0016_435_29_20190304_00008.jpg

Revegetation site sign. Spring 2016.

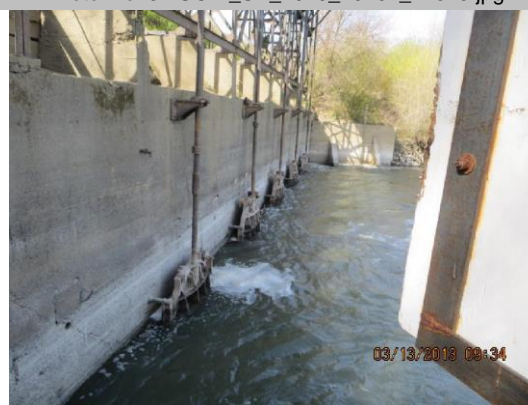
Photo 1 of 3 : UCIP_SP_2019_10164_17345.jpg

Slide gates at concrete headwall at river

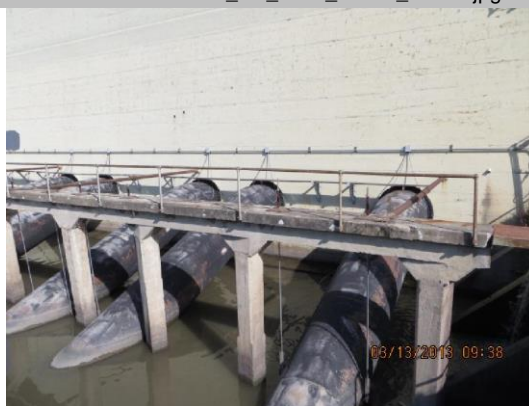
Photo 2 of 3 : UCIP_SP_2019_10164_17344.jpg

Pipes at entrance to pumping plant building on LS toe.

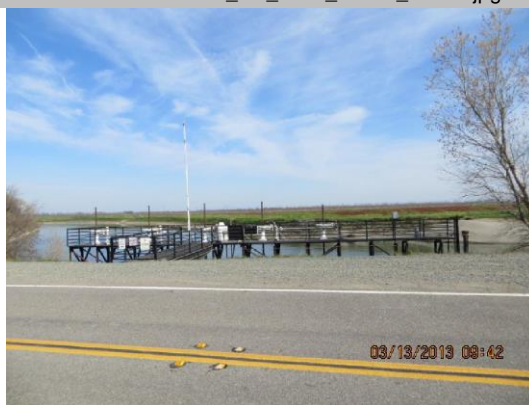
Photo 3 of 3 : UCIP_SP_2019_10164_17343.jpg

Slide gate actuators on WS shoulder.

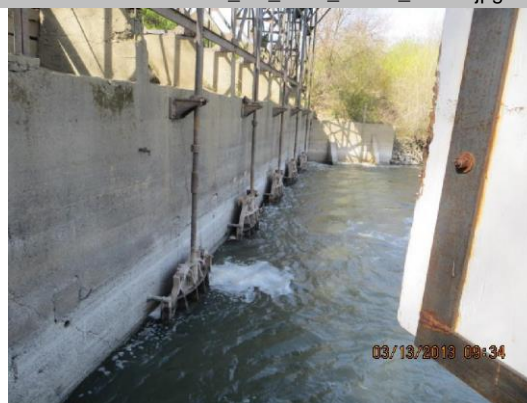
Photo 1 of 3 : UCIP_SP_2019_10165_17348.jpg

Slide gates and headwall on WS toe.

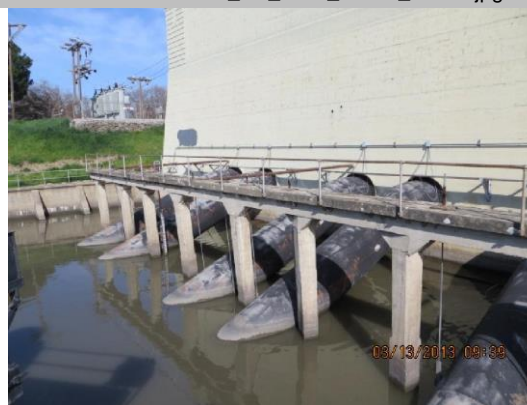
Photo 2 of 3 : UCIP_SP_2019_10165_17347.jpg

Pipes at inlet to pumphouse on LS toe.

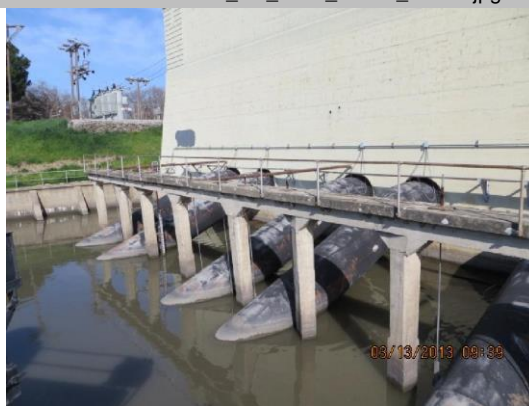
Photo 2 of 3 : UCIP_SP_2019_10168_17359.jpg

LM Start	9.76	Rating **	A/W	Issue No.	1569 (cont)	
LM End	9.76	Issue Type +	Ma	Location *		
Category	Supplemental			GPS Latitude/Longitude		
				Start		End
Item	DWR UCIP LMA Responsibility			38.862633 °		38.862633 °
				-121.792669 °		-121.792669 °
DWR ID	20365					
Comment Code						
Inspector Comment						
FS_ID:10168 DS_ID:20365 EP_NO: N/A Repair Type: No Action Needed Crossing Status: Found UCIP Comments: FIELD_STRUCT_DESC: 3 of 5: 60-inch reinforced concrete drainage culvert through the levee, 35 feet below the crown. Screw gate actuators on metal platform on the waterside (WS) shoulder. Large pumping plant building on the landside (LS) shoulder. Staff gauge to 47 feet on structure. [Additional Reference(s): DWR Levee Log, 2006. USACE Sacramento O&M Manual 130, May 1960 (HLM 9.87)]. FS Date: 3/13/2013

Pipe at inlet to pumphouse on LS toe.

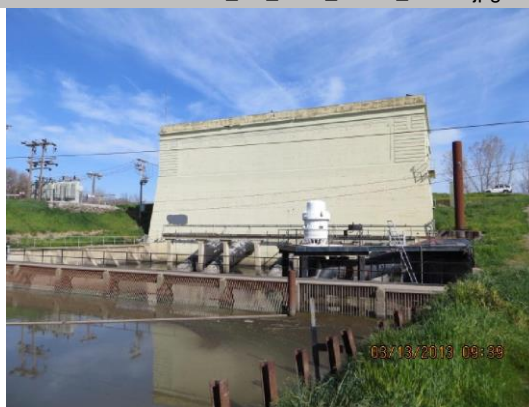
Photo 3 of 3 : UCIP_SP_2019_10168_17358.jpg

Pumphouse on LS.

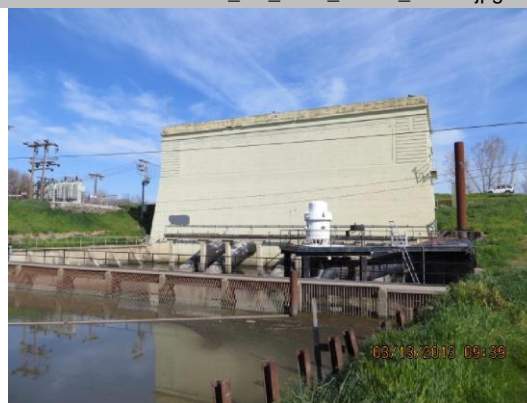
Photo 3 of 3 : UCIP_SP_2019_10167_17350.jpg

LM Start	9.76	Rating **	A/W	Issue No.	1570 (cont)	
LM End	9.76	Issue Type +	Ma	Location *		
Category	Supplemental			GPS Latitude/Longitude		
				Start		End
Item	DWR UCIP LMA Responsibility			38.862642 °		38.862642 °
				-121.792713 °		-121.792713 °
DWR ID	20366					
Comment Code						
Inspector Comment						
FS_ID:10167						
DS_ID:20366						
EP_NO: N/A						
Repair Type: No Action Needed						
Crossing Status: Found						
UCIP Comments:						
FIELD_STRUCT_DESC: 4 of 5: 60-inch reinforced concrete drainage culvert through the levee, 35 feet below the crown. Screw gate actuators on metal platform on the waterside (WS) shoulder. Large pumping plant building on the landside (LS) shoulder. Staff gauge to 47 feet on structure. [Additional Reference(s): DWR Levee Log, 2006. USACE Sacramento O&M Manual 130, May 1960 (HLM 9.87)].						
FS Date: 3/13/2013

Pumping plant on LS.

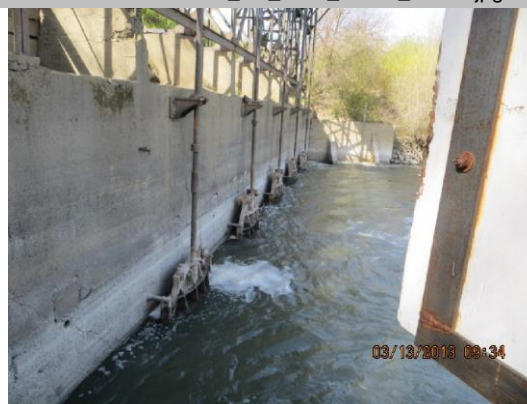
Photo 1 of 3 : UCIP_SP_2019_10169_17364.jpg

LM Start	9.76	Rating **	A/W	Issue No.	1571
LM End	9.76	Issue Type +	Ma	Location *	
Category	Supplemental			GPS Latitude/Longitude	
				Start	End
Item	DWR UCIP LMA Responsibility			38.862650 °	38.862650 °
				-121.792754 °	-121.792754 °
DWR ID	20367				
Comment Code					
Inspector Comment					
FS_ID:10169 DS_ID:20367 EP_NO: N/A Repair Type: No Action Needed Crossing Status: Found UCIP Comments: FIELD_STRUCT_DESC: 5 of 5: 60-inch reinforced concrete drainage culvert through the levee, 35 feet below the crown. Screw gate actuators on metal platform on the waterside (WS) shoulder. Large pumping plant building on the landside (LS) shoulder. Staff gauge to 47 feet on structure. [Additional Reference(s): DWR Levee Log, 2006. USACE Sacramento O&M Manual 130, May 1960 (HLM 9.87)]. FS Date: 3/13/2013

Slide gates and concrete headwall on WS toe.

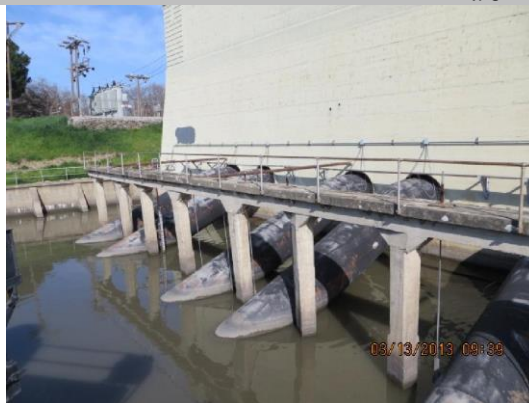
Photo 2 of 3 : UCIP_SP_2019_10169_17363.jpg

LM Start	9.76	Rating **	A/W	Issue No.	1571 (cont)	
LM End	9.76	Issue Type +	Ma	Location *		
Category	Supplemental			GPS Latitude/Longitude		
				Start		End
Item	DWR UCIP LMA Responsibility			38.862650 °		38.862650 °
				-121.792754 °		-121.792754 °
DWR ID	20367					
Comment Code						
Inspector Comment						
FS_ID:10169 DS_ID:20367 EP_NO: N/A Repair Type: No Action Needed Crossing Status: Found UCIP Comments: FIELD_STRUCT_DESC: 5 of 5: 60-inch reinforced concrete drainage culvert through the levee, 35 feet below the crown. Screw gate actuators on metal platform on the waterside (WS) shoulder. Large pumping plant building on the landside (LS) shoulder. Staff gauge to 47 feet on structure. [Additional Reference(s): DWR Levee Log, 2006. USACE Sacramento O&M Manual 130, May 1960 (HLM 9.87)]. FS Date: 3/13/2013

pipes at entrance to pumphouse on LS toe.

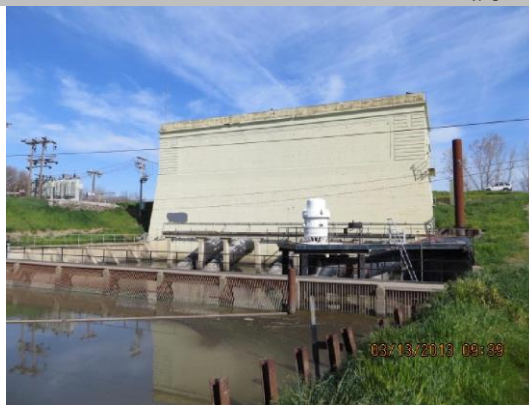
Photo 3 of 3 : UCIP_SP_2019_10169_17362.jpg

Pumphouse on LS.

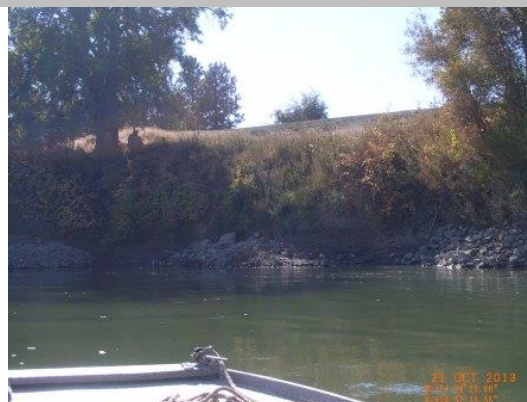
Photo 1 of 1 : SP_2019_NA0016_435_85_20190304_00020.jpg

LM Start	18.76	Rating **	A/W	Issue No.	85
LM End	18.78	Issue Type +	Ma	Location *	WS
Category	Supplemental			GPS Latitude/Longitude	
				Start	End
Item	2017 USACE Erosion Survey, DRAFT			38.954060 °	38.954312 °
				-121.840560 °	-121.840774 °
DWR ID	DWR_NA0016_01_f_2018_85				
Comment Code					
Inspector Comment					
2017 Site ID: SAC 111.0 R					
Status: Eroding					
2017 Field Notes: No observed change.					
Site History: 2009 - Minor erosion, should be repaired under maintenance. 2011 - Some new minor erosion at the toe.

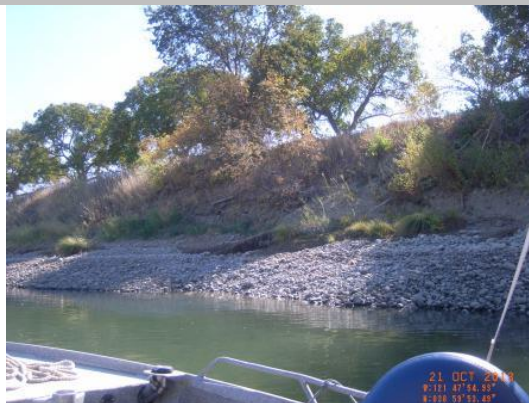
Photo 1 of 1 : SP_2019_NA0016_435_86_20190304_00021.jpg

LM Start	23.55	Rating **	A/W	Issue No.	86
LM End	23.65	Issue Type +	Ma	Location *	WS
Category	Supplemental			GPS Latitude/Longitude	
				Start	End
Item	2017 USACE Erosion Survey, DRAFT			38.997696 °	38.998336 °
				-121.797584 °	-121.799298 °
DWR ID	DWR_NA0016_01_f_2018_86				
Comment Code					
Inspector Comment					
2017 Site ID: SAC 115.9 R					
Status: Eroding					
2017 Field Notes: No observed change.					
Site History: 2008 - Slippage of cobbles off hard underlying toe material. 2011 - Minor slumping site. 2012 - Failing cobble site, site extended upstream. 2016 - New erosion pockets.					
DWR Inspector Comment: Cobble shelf within the water. There is a large section of berm. Does not appear to be actively eroding. Recommend monitoring.

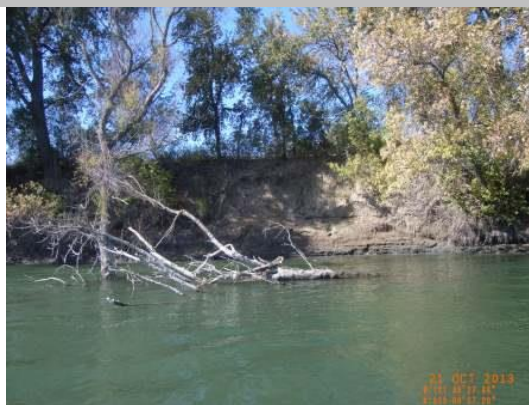
Photo 1 of 1 : SP_2019_NA0016_435_88_20190304_00023.jpg

LM Start	25.75	Rating **	A/W	Issue No.	88
LM End	25.91	Issue Type +	Ma	Location *	WS
Category	Supplemental			GPS Latitude/Longitude	
				Start	End
Item	2017 USACE Erosion Survey, DRAFT			39.014499 °	39.016401 °
				-121.825880 °	-121.824230 °
DWR ID	DWR_NA0016_01_f_2018_88				
Comment Code					
Inspector Comment					
2017 Site ID: SAC 118.0 R					
Status: Eroding					
2017 Field Notes: No observed change.					
Site History: 2008 - Whole bank is eroding, nearly vertical slope with cohesive toe. Bed is very deep along the toe (greater than 30 ft deep at 20 ft from the shore). 2011 - Some new minor erosion. 2016 - Minor new erosion.

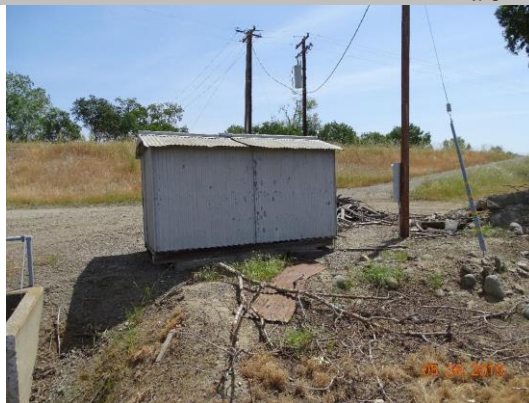
Photo 3 of 3 : UCIP_SP_2019_53985_79219.jpg

Comment Code					
Inspector Comment					
FS_ID:53985 DS_ID:20341 EP_NO: 9358 Repair Type: No Action Needed Crossing Status: Found UCIP Comments: 05/06/2019 Crossing is in good condition. (DWR UCIP - O.Yakimov) FIELD_STRUCT_DESC: 16-inch steel drainage pipe through the levee, 8.5 feet below the crown. Siphon breaker inside a 24-inch corrugated metal riser unit on the waterside (WS) slope. Pump inside pump house on the landside (LS). Overhead power line crosses the levee. Pole on the LS shoulder. (one 12-inch, one 16-inch, and one 24-inch pipes [HLM 29.02] authorized under Automatic Board Order (ABO) issued as Permit No. 9358, 1974 - Crocker National Bank (Trustee)). [Additional Reference(s): DWR Levee Log, 2006. USACE Sacramento O&M Manual 131, May 1960 (HLM 29.02)]. FS Date: 5/6/2019 12:51:38 PM

Pumphouse and sump on LS looking from landside

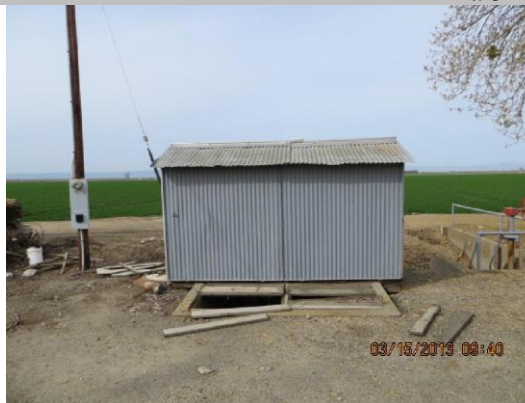
Photo 3 of 3 : UCIP_SP_2019_53986_17569.jpg

Item	DWR UCIP LMA Responsibility			39.048295 °	39.048295 °	
				-121.841088 °	-121.841088 °	
DWR ID	20259					
Comment Code						
Inspector Comment						
FS_ID:53986 DS_ID:20259 EP_NO: 9358 Repair Type: No Action Needed Crossing Status: Found UCIP Comments: 05/06/2019 Crossing is in good condition. (DWR UCIP - O.Yakimov) FIELD_STRUCT_DESC: 10-inch steel drainage pipe through the levee, 8 feet below the crown. Siphon breaker in a 24-inch corrugated metal riser on the waterside (WS) slope. Slide gate at base of pump house on landside (LS) toe. Pump over sump at pump house on LS toe. Overhead power line crosses the levee. Pole on the LS shoulder. (one 12-inch, one 16-inch, and one 24-inch pipes [HLM 29.02] authorized under Automatic Board Order (ABO) issued as Permit No. 9358, 1974 - Crocker National Bank (Trustee)). [Additional Reference(s): DWR Levee Log, 2006. USACE Sacramento O&M Manual 131, May 1960 (HLM 29.02)]. FS Date: 5/6/2019 2:23:55 PM

Pumphouse over sump on LS toe.

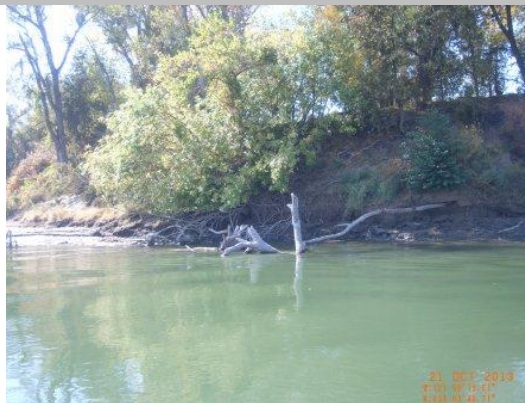
Photo 1 of 1 : SP_2019_NA0016_435_89_20190304_00024.jpg

LM Start	29.69	Rating **	A/W	Issue No.	89
LM End	29.73	Issue Type +	Ma	Location *	WS
Category	Supplemental			GPS Latitude/Longitude	
				Start	End
Item	2017 USACE Erosion Survey, DRAFT			39.063209 °	39.063997 °
				-121.838927 °	-121.839335 °
DWR ID	DWR_NA0016_01_f_2018_89				
Comment Code					
Inspector Comment					
2017 Site ID: SAC 122.0 R					
Status: Eroding					
2017 Field Notes: Minor new erosion at toe.					
Site History: 1997 - Mass failure of the lower cohesive bank and toe.					
2000 - Still eroding, steeply dipping foresets in the toe are falling off.					
2010 - Some new erosion and some new deposition. Eddy current off the upstream rock. 2011 - Still plenty of berm left. 2016 - Minor new erosion.

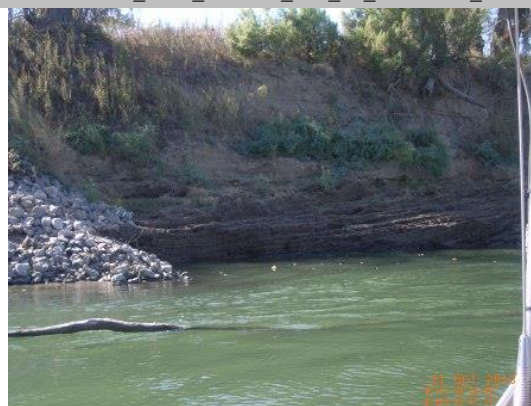
Photo 1 of 1 : SP_2019_NA0016_435_91_20190304_00026.jpg

Comment Code					
Inspector Comment					
2017 Site ID: SAC 122.3 R Status: Eroding 2017 Field Notes: Fresh slumping erosion at toe. Site History: 2002 - Upstream end has recent slope failure and exposure of tree roots. 2003 - Some new minor slope erosion with new snags on the bank. 2004 - Appears a little worse. 2005 - Scallop in bank at the upstream end looks worse. 2009 - Minimal new erosion, Berm width is still large, but one large event or one fallen tree and it could go fast. 2010 - New erosion, bank is nearly all vertical from slumping. Site looks bad. 2011 - Site continues to look bad. 2012 - Minor new erosion. 2015 - Undermining of toe rock. 2016 - Site extended upstream, new erosion and exposed tree roots.					
DWR Inspector Comment: No erosion within the prism and vegetation appears to be stabilizing the bank. Recommend monitoring.

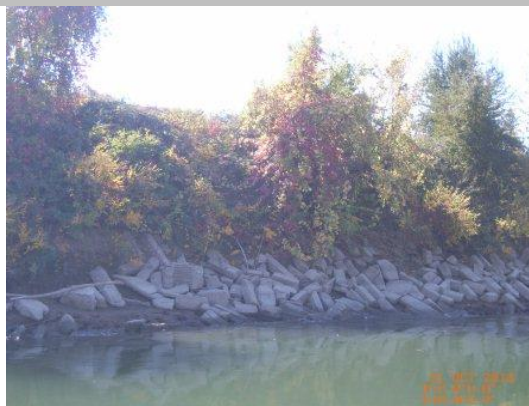
Photo 1 of 1 : SP_2019_NA0016_435_92_20190304_00027.jpg

LM Start	31.43	Rating **	A/W	Issue No.	92
LM End	31.45	Issue Type +	Ma	Location *	WS
Category	Supplemental			GPS Latitude/Longitude	
				Start	End
Item	2017 USACE Erosion Survey, DRAFT			39.067004 °	39.066901 °
				-121.866913 °	-121.867322 °
DWR ID	DWR_NA0016_01_f_2018_92				
Comment Code					
Inspector Comment					
2017 Site ID: SAC 123.7 R Status: Eroding 2017 Field Notes: No observed change. Site History: 1997 - Erosion into the levee section; old concrete rubble loss at toe; transition between the rock upstream and the cobble downstream. 2000 - Cohesive bench with concrete slabs on top; 25 ft deep scour hole on the downstream end. DWR Inspector Comment: Appears to be stable. Plenty of berm and cobble left.

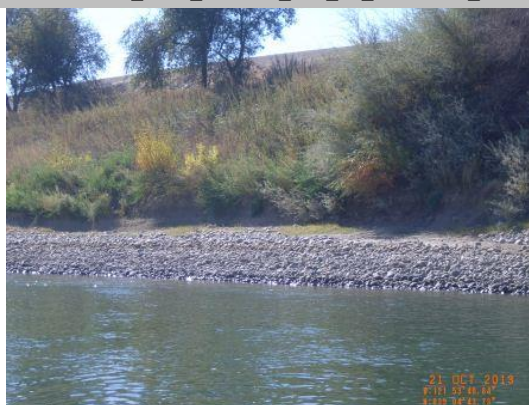
Photo 1 of 1 : SP_2019_NA0016_435_93_20190304_00028.jpg

LM Start	33.29	Rating **	A/W	Issue No.	93
LM End	33.37	Issue Type +	Ma	Location *	WS
Category	Supplemental			GPS Latitude/Longitude	
				Start	End
Item	2017 USACE Erosion Survey, DRAFT			39.078340 °	39.079351 °
				-121.894656 °	-121.895317 °
DWR ID	DWR_NA0016_01_f_2018_93				
Comment Code					
Inspector Comment					
2017 Site ID: SAC 125.6 R					
Status: Eroding					
2017 Field Notes: No observed change.					
Site History: 2008 - Slow erosion of the hard toe. 2010 - Cobble rubble is failing, erosion is into the toe of the levee, with vertical slumping.					
2012 - Site appears to be relatively stable. 2013 - New animal holes.

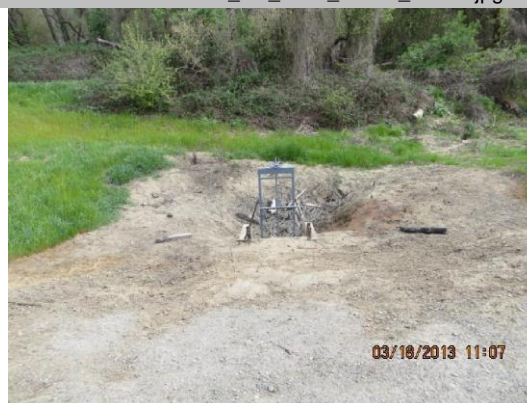
Photo 1 of 3 : UCIP_SP_2019_10426_17705.jpg

Comment Code						
Inspector Comment						
FS_ID:10426 DS_ID:20345 EP_NO: 9374 Repair Type: Non-Urgent Crossing Status: Found UCIP Comments: Verify if pipe is abandoned with landowner and remove or abandon properly if necessary. FIELD_STRUCT_DESC: *ABANDONED* 3 of 3: 24-inch concrete encased steel drainage pipe through the levee, 17 feet below the crown. Slide gate on concrete headwall on waterside (WS) end. Walkway to control gate and gate valve on landside (LS) end. (24-inch pipe [HLM 36.61] authorized under Automatic Board Order (ABO) issued as Permit No. 9374, 1974 - Richard H. Moore). [Additional Reference(s): USACE Sacramento O&M Manual 131, May 1960 (HLM 36.61)]. FS Date: 3/18/2013

Slide gate on WS toe.

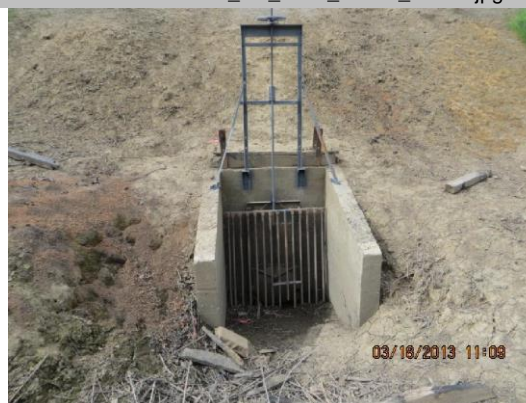
Photo 3 of 3 : UCIP_SP_2019_10426_17703.jpg

Item	DWR UCIP LMA Responsibility			39.111233 °		39.111233 °
				-121.911450 °		-121.911450 °
DWR ID	20345					
Comment Code						
Inspector Comment						
FS_ID:10426 DS_ID:20345 EP_NO: 9374 Repair Type: Non-Urgent Crossing Status: Found UCIP Comments: Verify if pipe is abandoned with landowner and remove or abandon properly if necessary. FIELD_STRUCT_DESC: *ABANDONED* 3 of 3: 24-inch concrete encased steel drainage pipe through the levee, 17 feet below the crown. Slide gate on concrete headwall on waterside (WS) end. Walkway to control gate and gate valve on landside (LS) end. (24-inch pipe [HLM 36.61] authorized under Automatic Board Order (ABO) issued as Permit No. 9374, 1974 - Richard H. Moore). [Additional Reference(s): USACE Sacramento O&M Manual 131, May 1960 (HLM 36.61)]. FS Date: 3/18/2013

Outlet/inlet on WS toe.

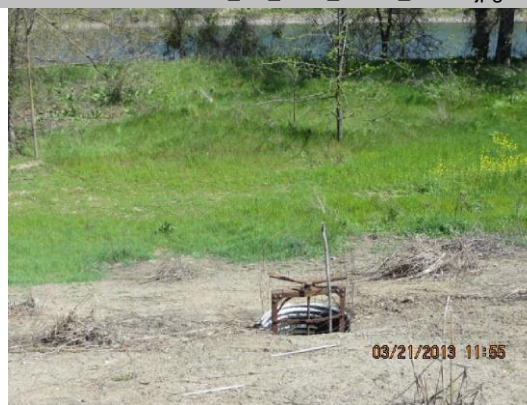
Photo 1 of 3 : UCIP_SP_2019_10535_17877.jpg

Comment Code					
Inspector Comment					
FS_ID:10535					
DS_ID:20288					
EP_NO: N/A					
Repair Type: No Action Needed					
Crossing Status: Found					
UCIP Comments:					
FIELD_STRUCT_DESC: 24-inch drainage pipe of an unknown material through the levee, 19 feet below the crown. 6-foot diameter corrugated metal standpipe on the landside (LS) toe. Pump and 24-inch pipe on the LS. Slide gate in corrugated metal riser unit on waterside (WS) slope. Concrete block wall at WS toe for discharge line. (Modified under Permit No. 8587, 1973 - Anthony E. Steidlmaier). [Additional Reference(s): DWR Levee Log, 2006. USACE Sacramento O&M Manual 131, May 1960 (HLM 41.56)].					
FS Date: 3/21/2013

Slide gate in CMP riser on WS slope.

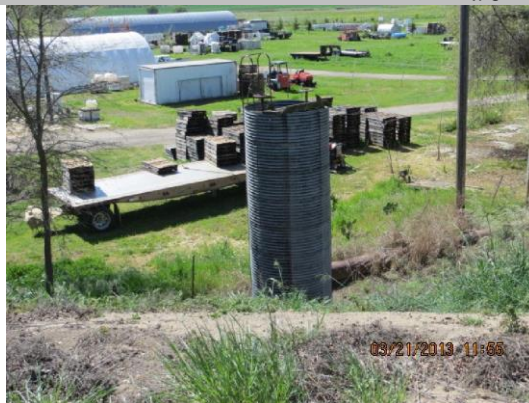
Photo 2 of 3 : UCIP_SP_2019_10535_17876.jpg

Item	DWR UCIP LMA Responsibility			39.152347 °		39.152347 °
				-121.920610 °		-121.920610 °
DWR ID	20288					
Comment Code						
Inspector Comment						
FS_ID:10535 DS_ID:20288 EP_NO: N/A Repair Type: No Action Needed Crossing Status: Found UCIP Comments: FIELD_STRUCT_DESC: 24-inch drainage pipe of an unknown material through the levee, 19 feet below the crown. 6-foot diameter corrugated metal standpipe on the landside (LS) toe. Pump and 24-inch pipe on the LS. Slide gate in corrugated metal riser unit on waterside (WS) slope. Concrete block wall at WS toe for discharge line. (Modified under Permit No. 8587, 1973 - Anthony E. Steidlmayer). [Additional Reference(s): DWR Levee Log, 2006. USACE Sacramento O&M Manual 131, May 1960 (HLM 41.56)]. FS Date: 3/21/2013

6-foot diameter CMP riser with slide gates on LS toe.

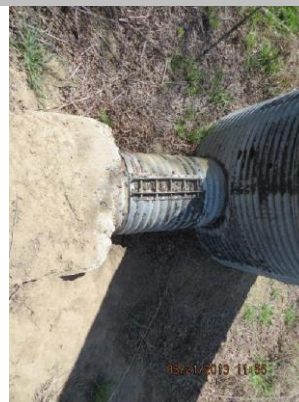
Photo 3 of 3 : UCIP_SP_2019_10535_17875.jpg

24-inch CMP at connection to CMP riser on LS toe.

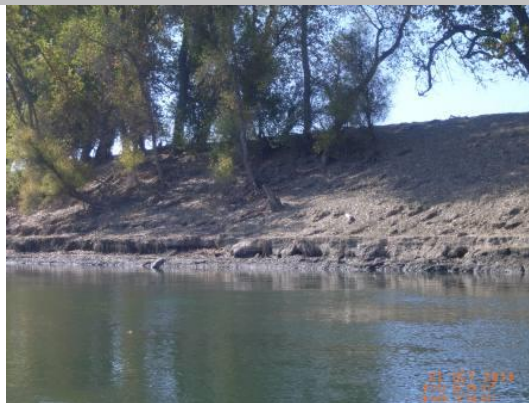
Photo 1 of 1 : SP_2019_NA0016_435_95_20190304_00030.jpg

LM Start	42.90	Rating **	A/W	Issue No.	95
LM End	43.09	Issue Type +	Ma	Location *	WS
Category	Supplemental			GPS Latitude/Longitude	
				Start	End
Item	2017 USACE Erosion Survey, DRAFT			39.172501 °	39.174949 °
				-121.939053 °	-121.940737 °
DWR ID	DWR_NA0016_01_f_2018_95				
Comment Code					
Inspector Comment					
2017 Site ID: SAC 136.6 R					
Status: Eroding					
2017 Field Notes: New erosion observed along the entire bank slope.					
Site History: 2010 - Lower portion of 136.7 that did not extend far enough. Abrupt transition from upstream site. 2012 - Site extended upstream, minor new erosion. 2013 - Minor new erosion at the toe. New tree popout. Downstream limit extended. 2016 - Site continues to worsen, fresh erosion at toe.

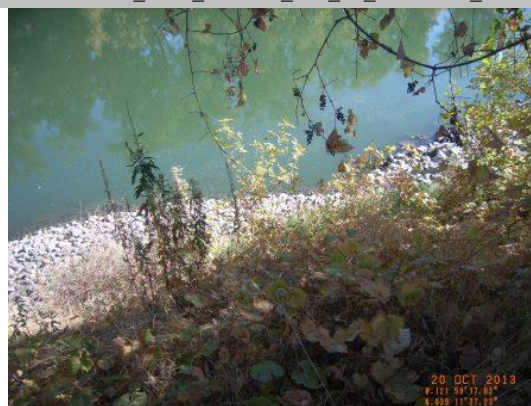
Photo 1 of 1 : SP_2019_NA0016_435_97_20190304_00032.jpg

LM Start	47.62	Rating **	A/W	Issue No.	97
LM End	47.77	Issue Type +	Ma	Location *	WS
Category	Supplemental			GPS Latitude/Longitude	
				Start	End
Item	2017 USACE Erosion Survey, DRAFT			39.193769 °	39.195595 °
				-121.987901 °	-121.988621 °
DWR ID	DWR_NA0016_01_f_2018_97				
Comment Code					
Inspector Comment					
2017 Site ID: SAC 141.5 R					
Status: Eroding					
2017 Field Notes: No observed change.					
Site History: 2010 - Old cobble site starting to unravel at toe. 2011 - Cobbles continue to unravel. 2013 - Site extended downstream to revetment.

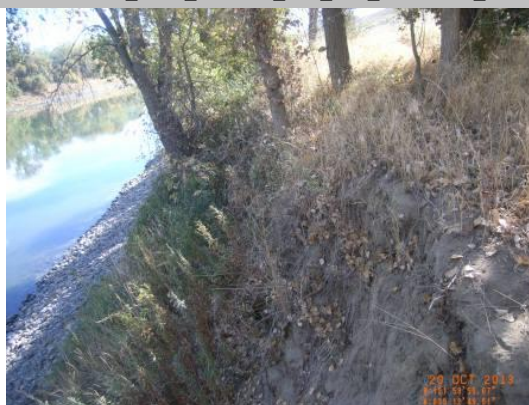
Photo 1 of 1 : SP_2019_NA0016_435_105_20190304_00036.jpg

LM Start	49.46	Rating **	A/W	Issue No.	105
LM End	49.57	Issue Type +	Ma	Location *	WS
Category	Supplemental			GPS Latitude/Longitude	
				Start	End
Item	2017 USACE Erosion Survey, DRAFT			39.213608 °	39.213869 °
				-121.997543 °	-121.999641 °
DWR ID	DWR_NA0016_01_f_2018_105				
Comment Code					
Inspector Comment					
2017 Site ID: SAC 143.5 R Status: Eroding 2017 Field Notes: New erosion along lower slope. Site History: 2011 - Multiple scallops, one tree pop out. Old cobble site starting to unravel at midbank. 2012 - Mid bank slumping continues to worsen but cobble at the toe appears stable.					
DWR Inspector Comment: Erosion on the waterside berm. Recommend monitoring.
